Existing Assessment

Existing Building Condition

Chamberlain Street School

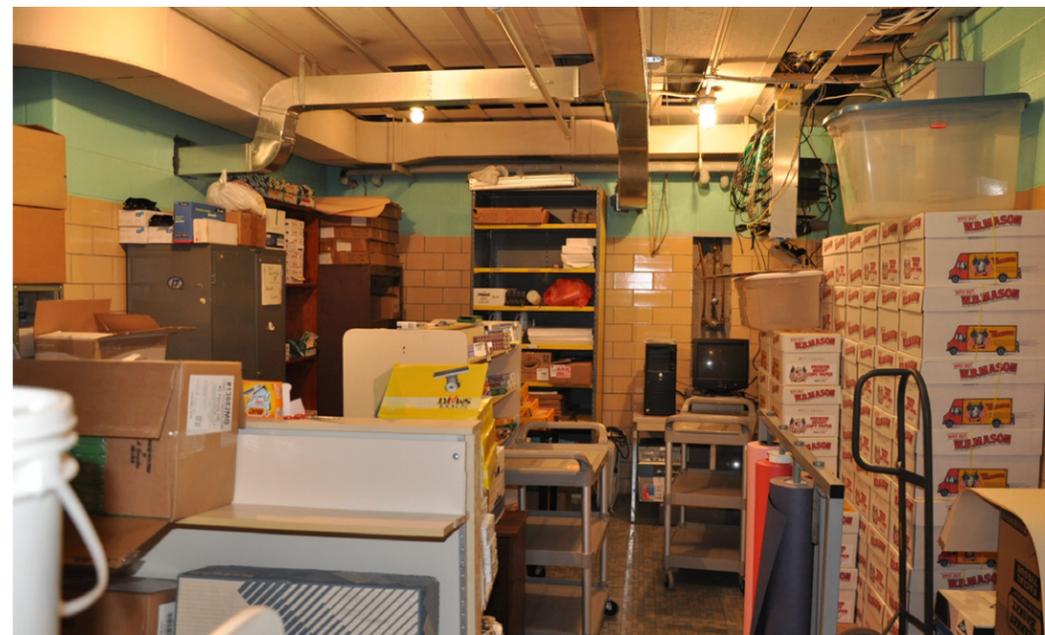
Lack of storage should be addressed for general school supplies, art supplies, and technology equipment. Above photo is of only storage room in building housing all three.

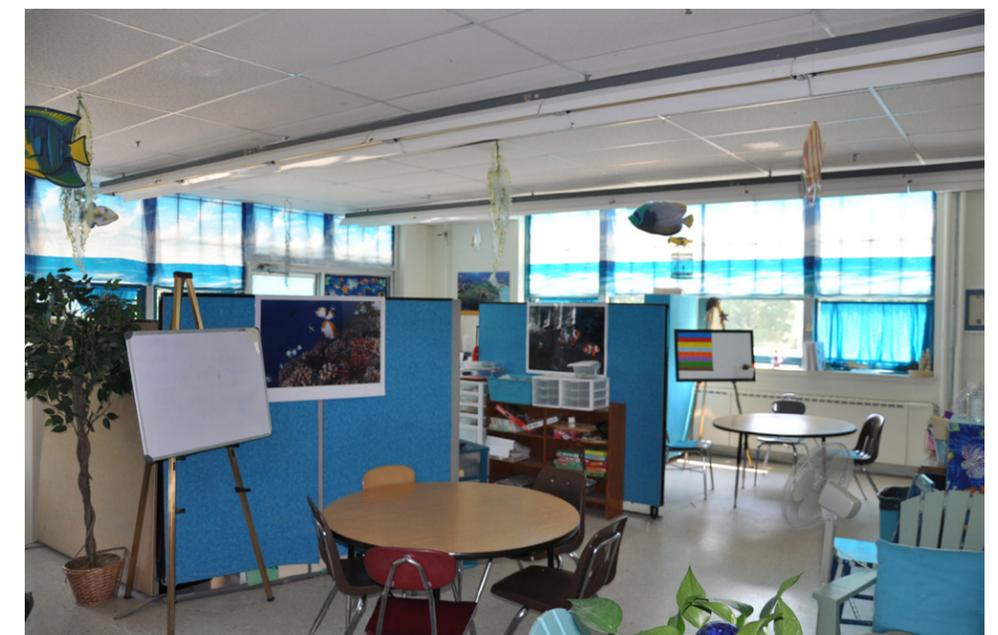
A former classroom is used as a Resource room, Special education area, and Intervention spaces. Administrators noted this open flexible concept works well, if they had more.

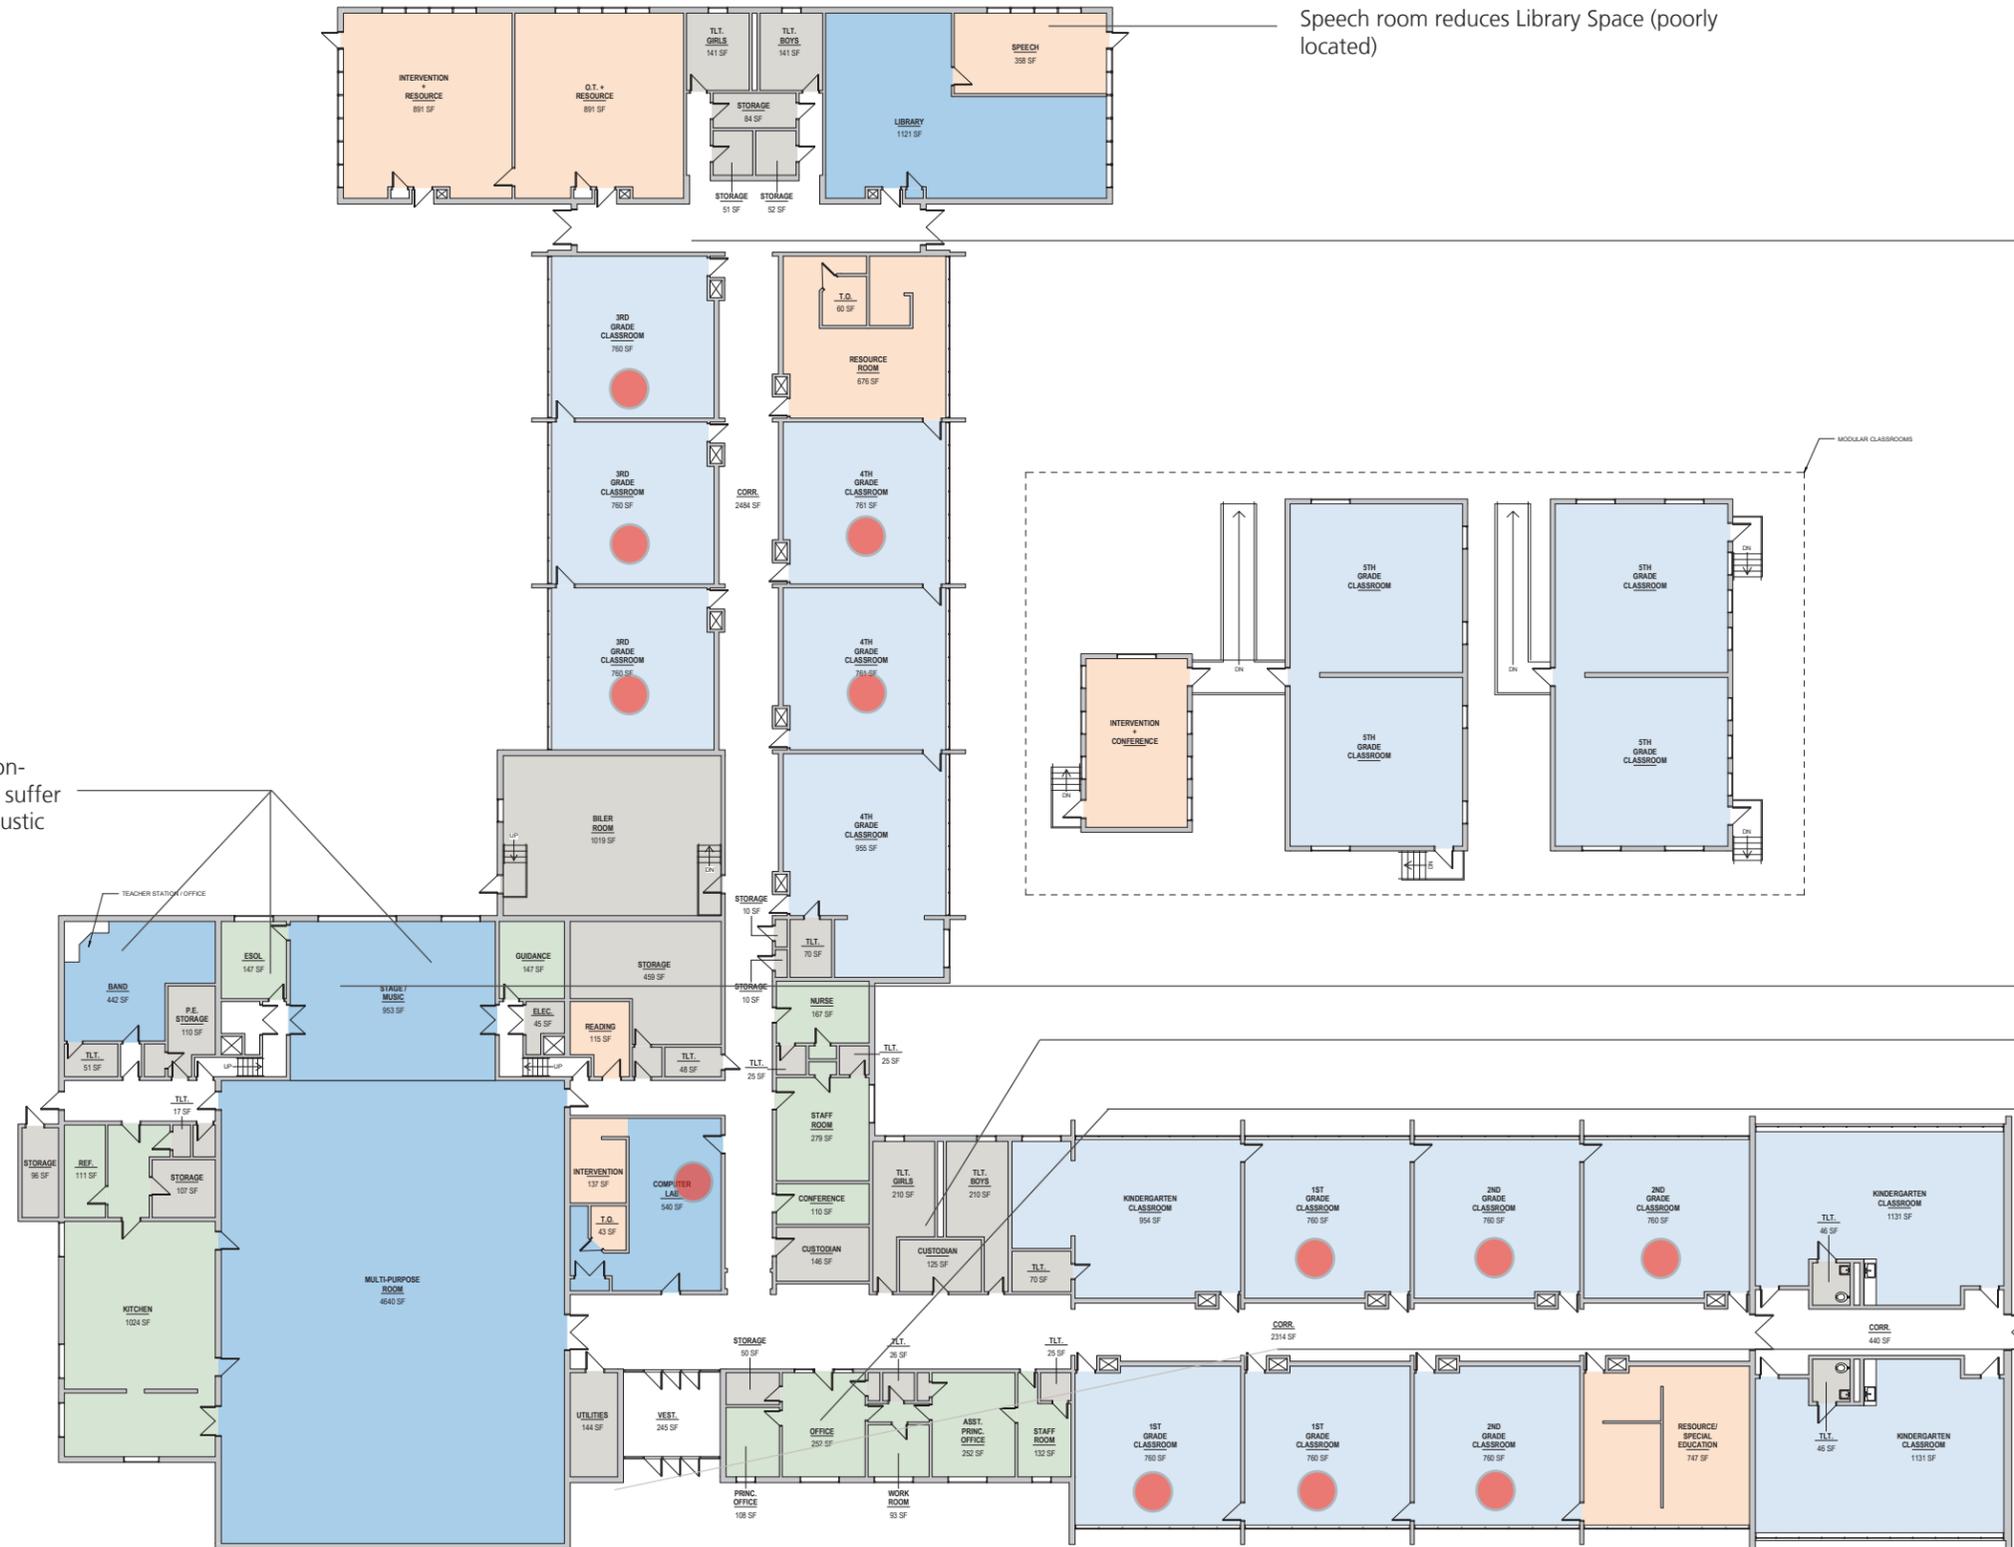
Undersized Classroom
Note: These classrooms cannot feasibly be expanded to 900sf standards. To meet NH DOE standards of 36sf per student, each of these classrooms should be limited to 21 students

Lacking Art Classroom

These areas non-accessible and suffer from poor acoustic separation

Speech room reduces Library Space (poorly located)

Lacking Music Classroom (stage lacks acoustic separation).

Lack of restrooms for both students adults

Lack administrative conference rooms

Poor lines of site create a non-super-visible entrance
