The following report includes the assessments and recommendations for the Rochester School District's Pre-School through 8th Grade facilities as prepared during the summer of 2012. The information included in this report was created by Lavallee Brensinger Architects in cooperation with The Rochester School District, its administrators, and the administrators at each of the Primary Schools considered. This document reflects assessments of the existing schools created through tours of each facility, interviews with school principals and assistant principals, building programming (based on current curriculum), current building codes, and NH State Education Standards.

Project Goals

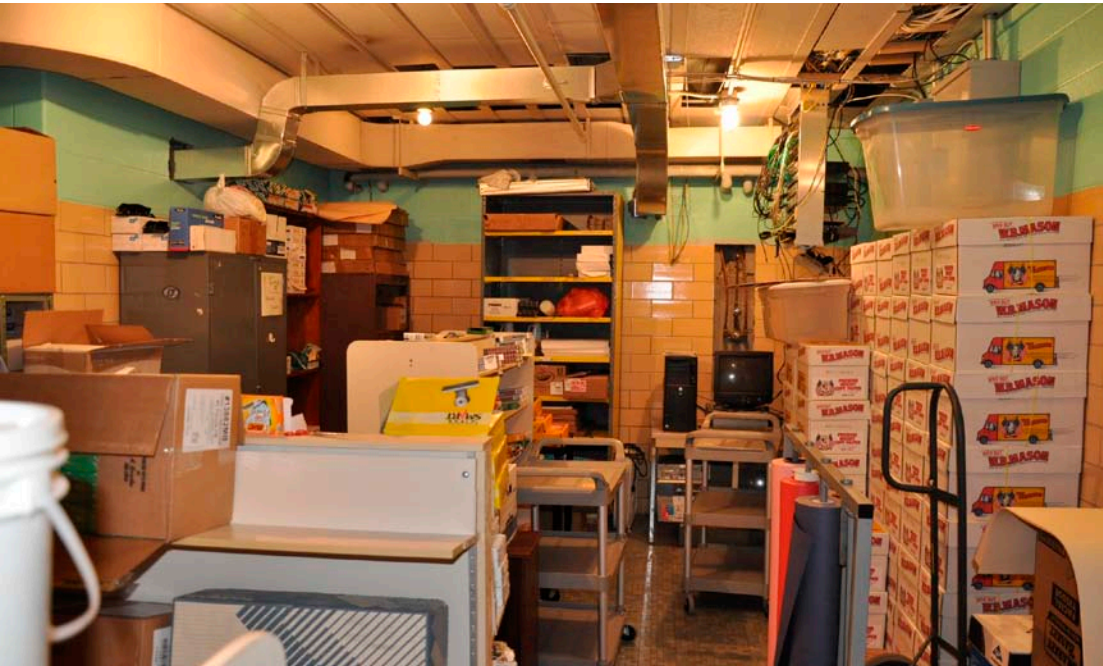
Lack of storage should be addressed for general school supplies, art supplies, and technology equipment. Above photo is of only storage room in building housing all three.

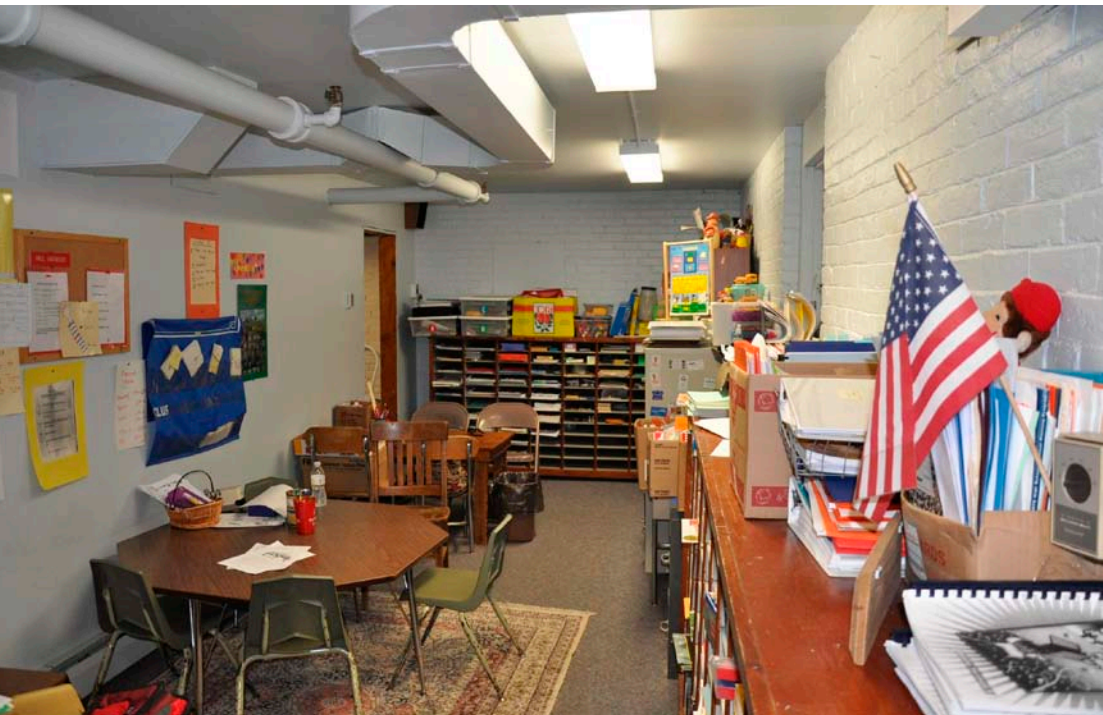
The basement intervention space also houses storage of classroom supplies, serves as access to storage and mechanical areas and guidance, and is little more than a re-purposed corridor.

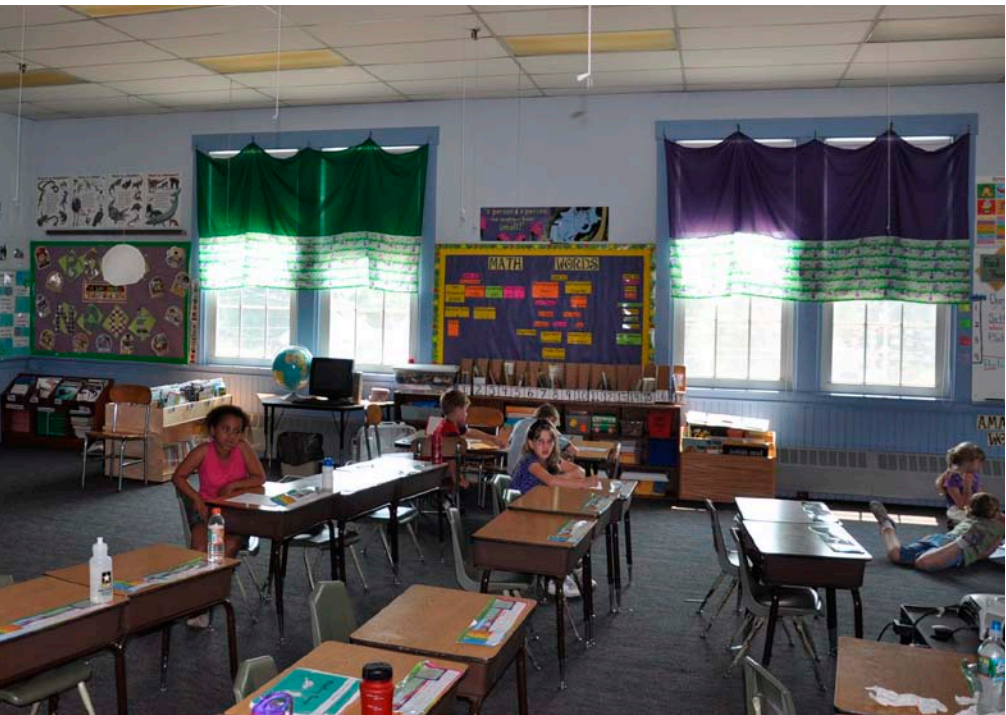
Nicely proportioned classrooms.

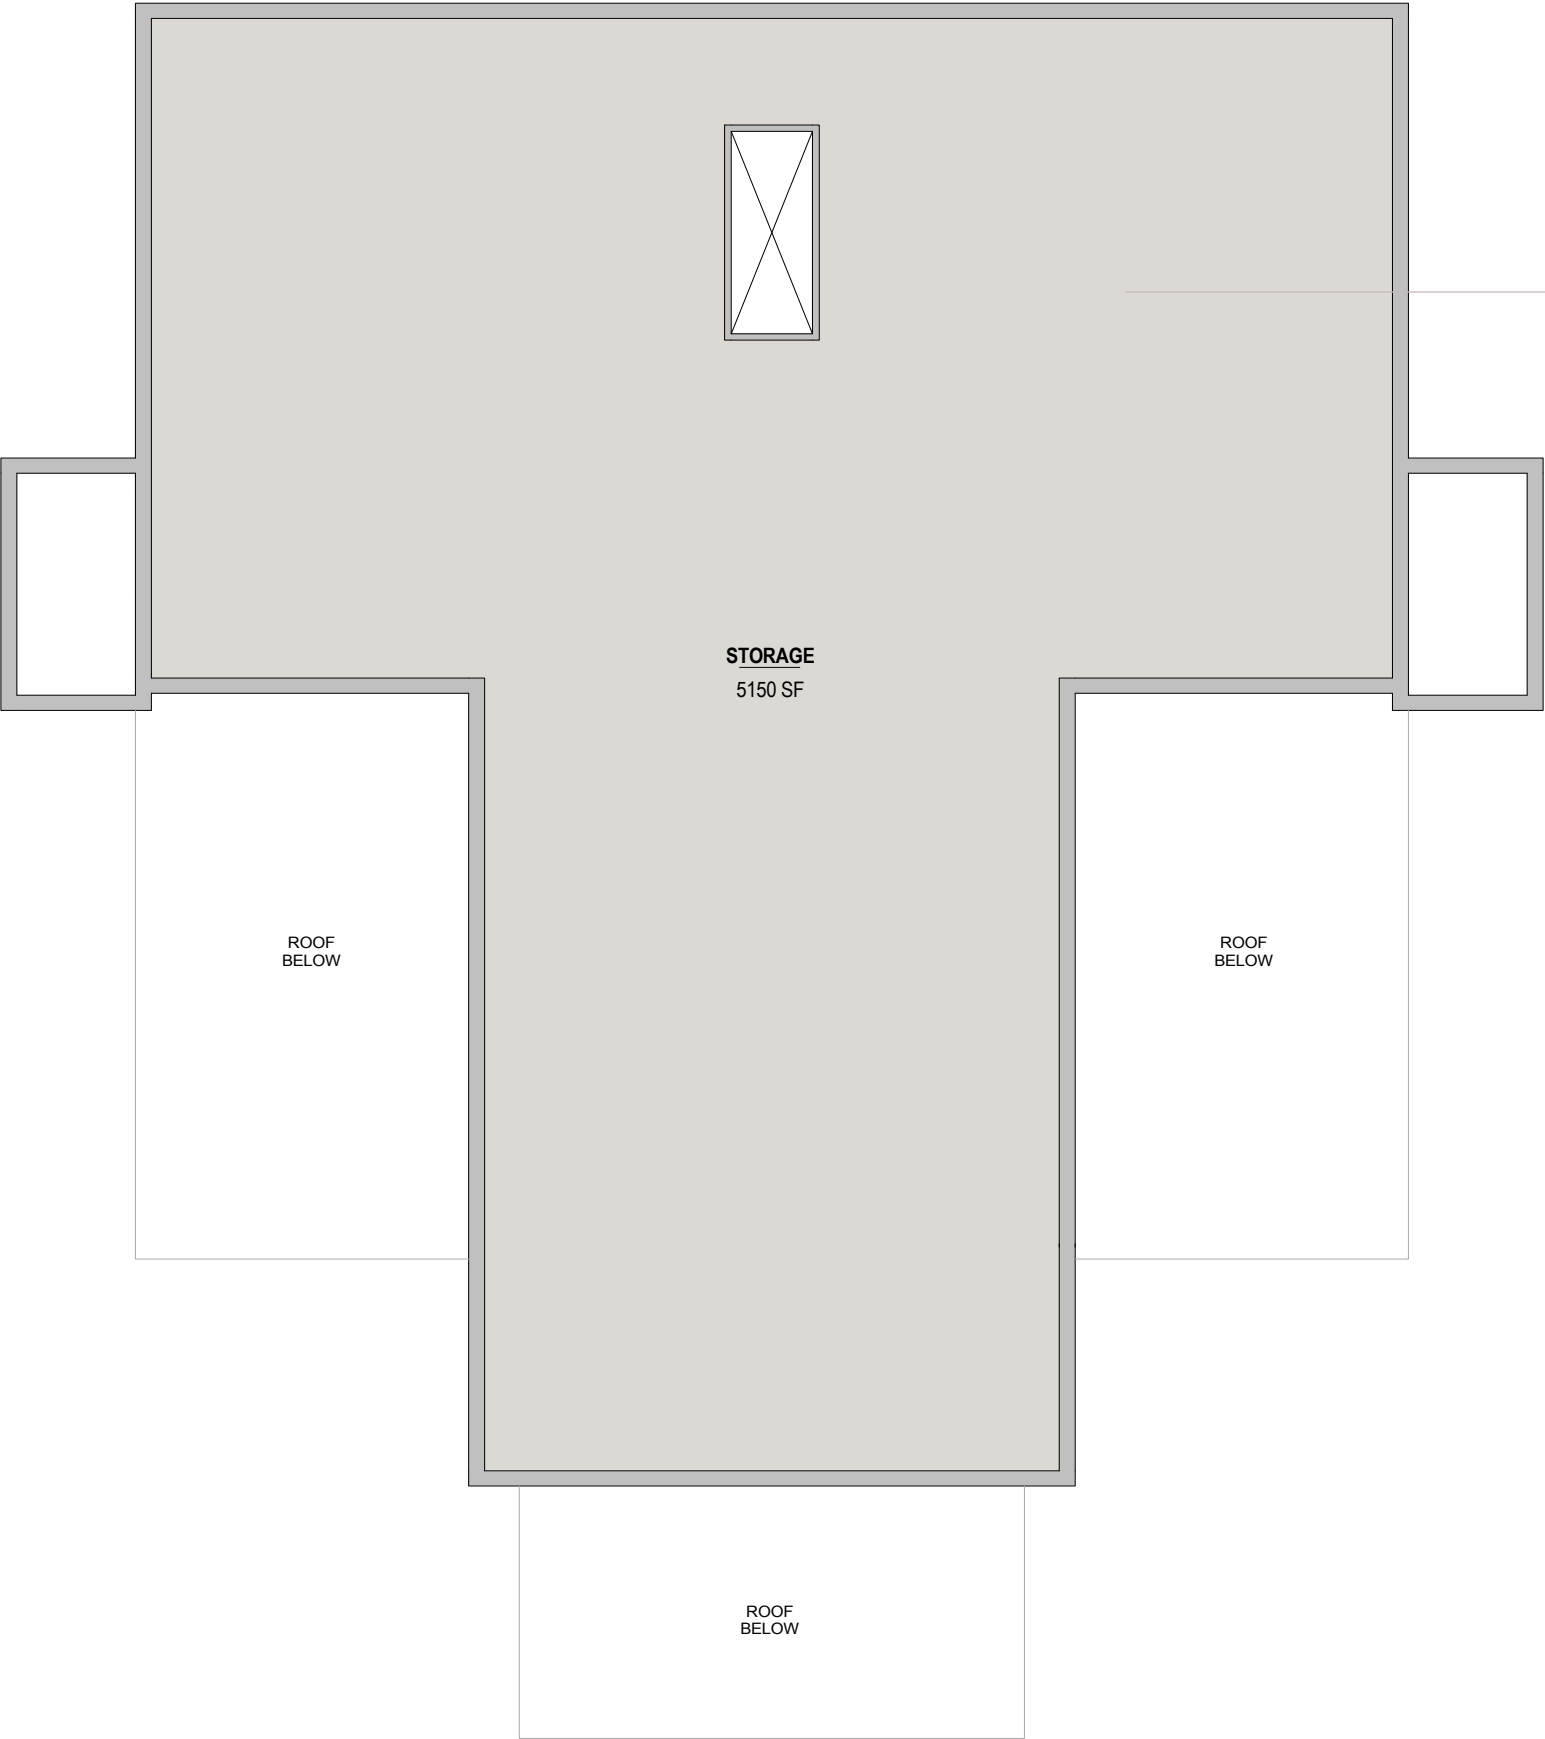
Attic Space not easily suitable for education space due to mechanical equipment and air quality

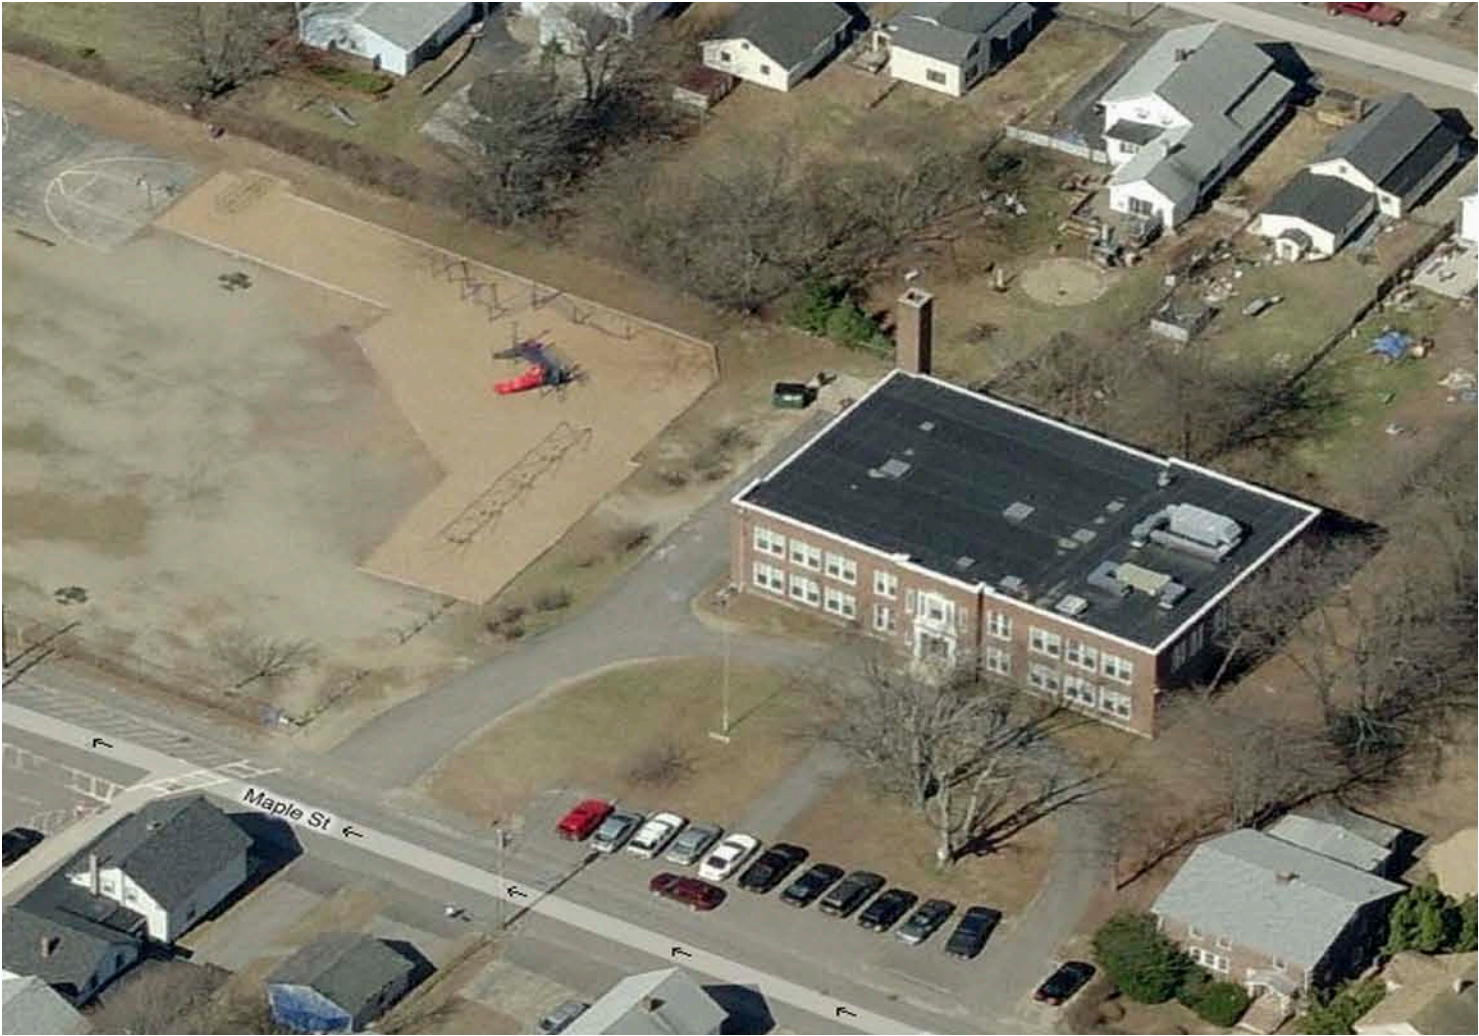
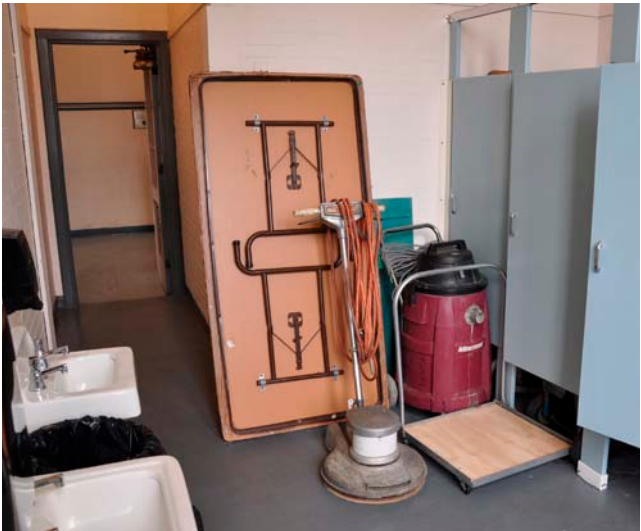
Added storage should be considered as part of any renovation to avoid storing of items in improper locations.

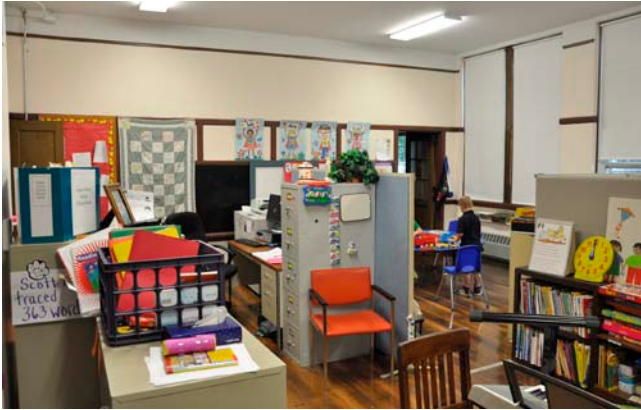
Special Education and Intervention areas are adequate and well utilized.

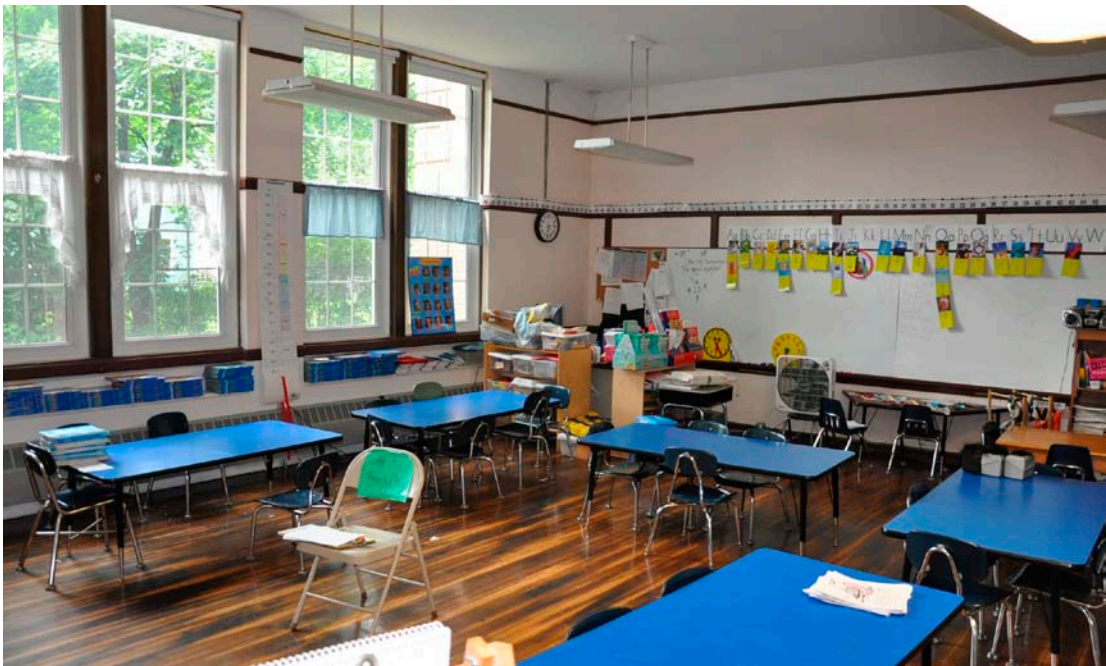
Classrooms, although small, are well designed with high ceilings, lots of natural light, and built-in storage.

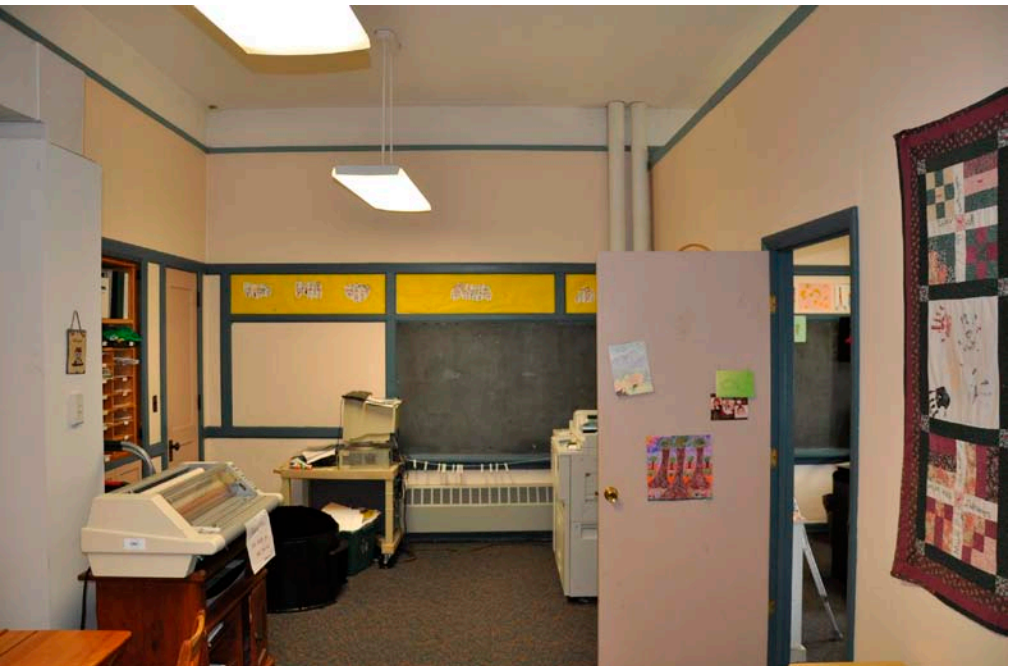
The Main Office area, including the Principal's Office do not achieve acoustic separation as the partitions do not extend all the way up, offering no privacy.

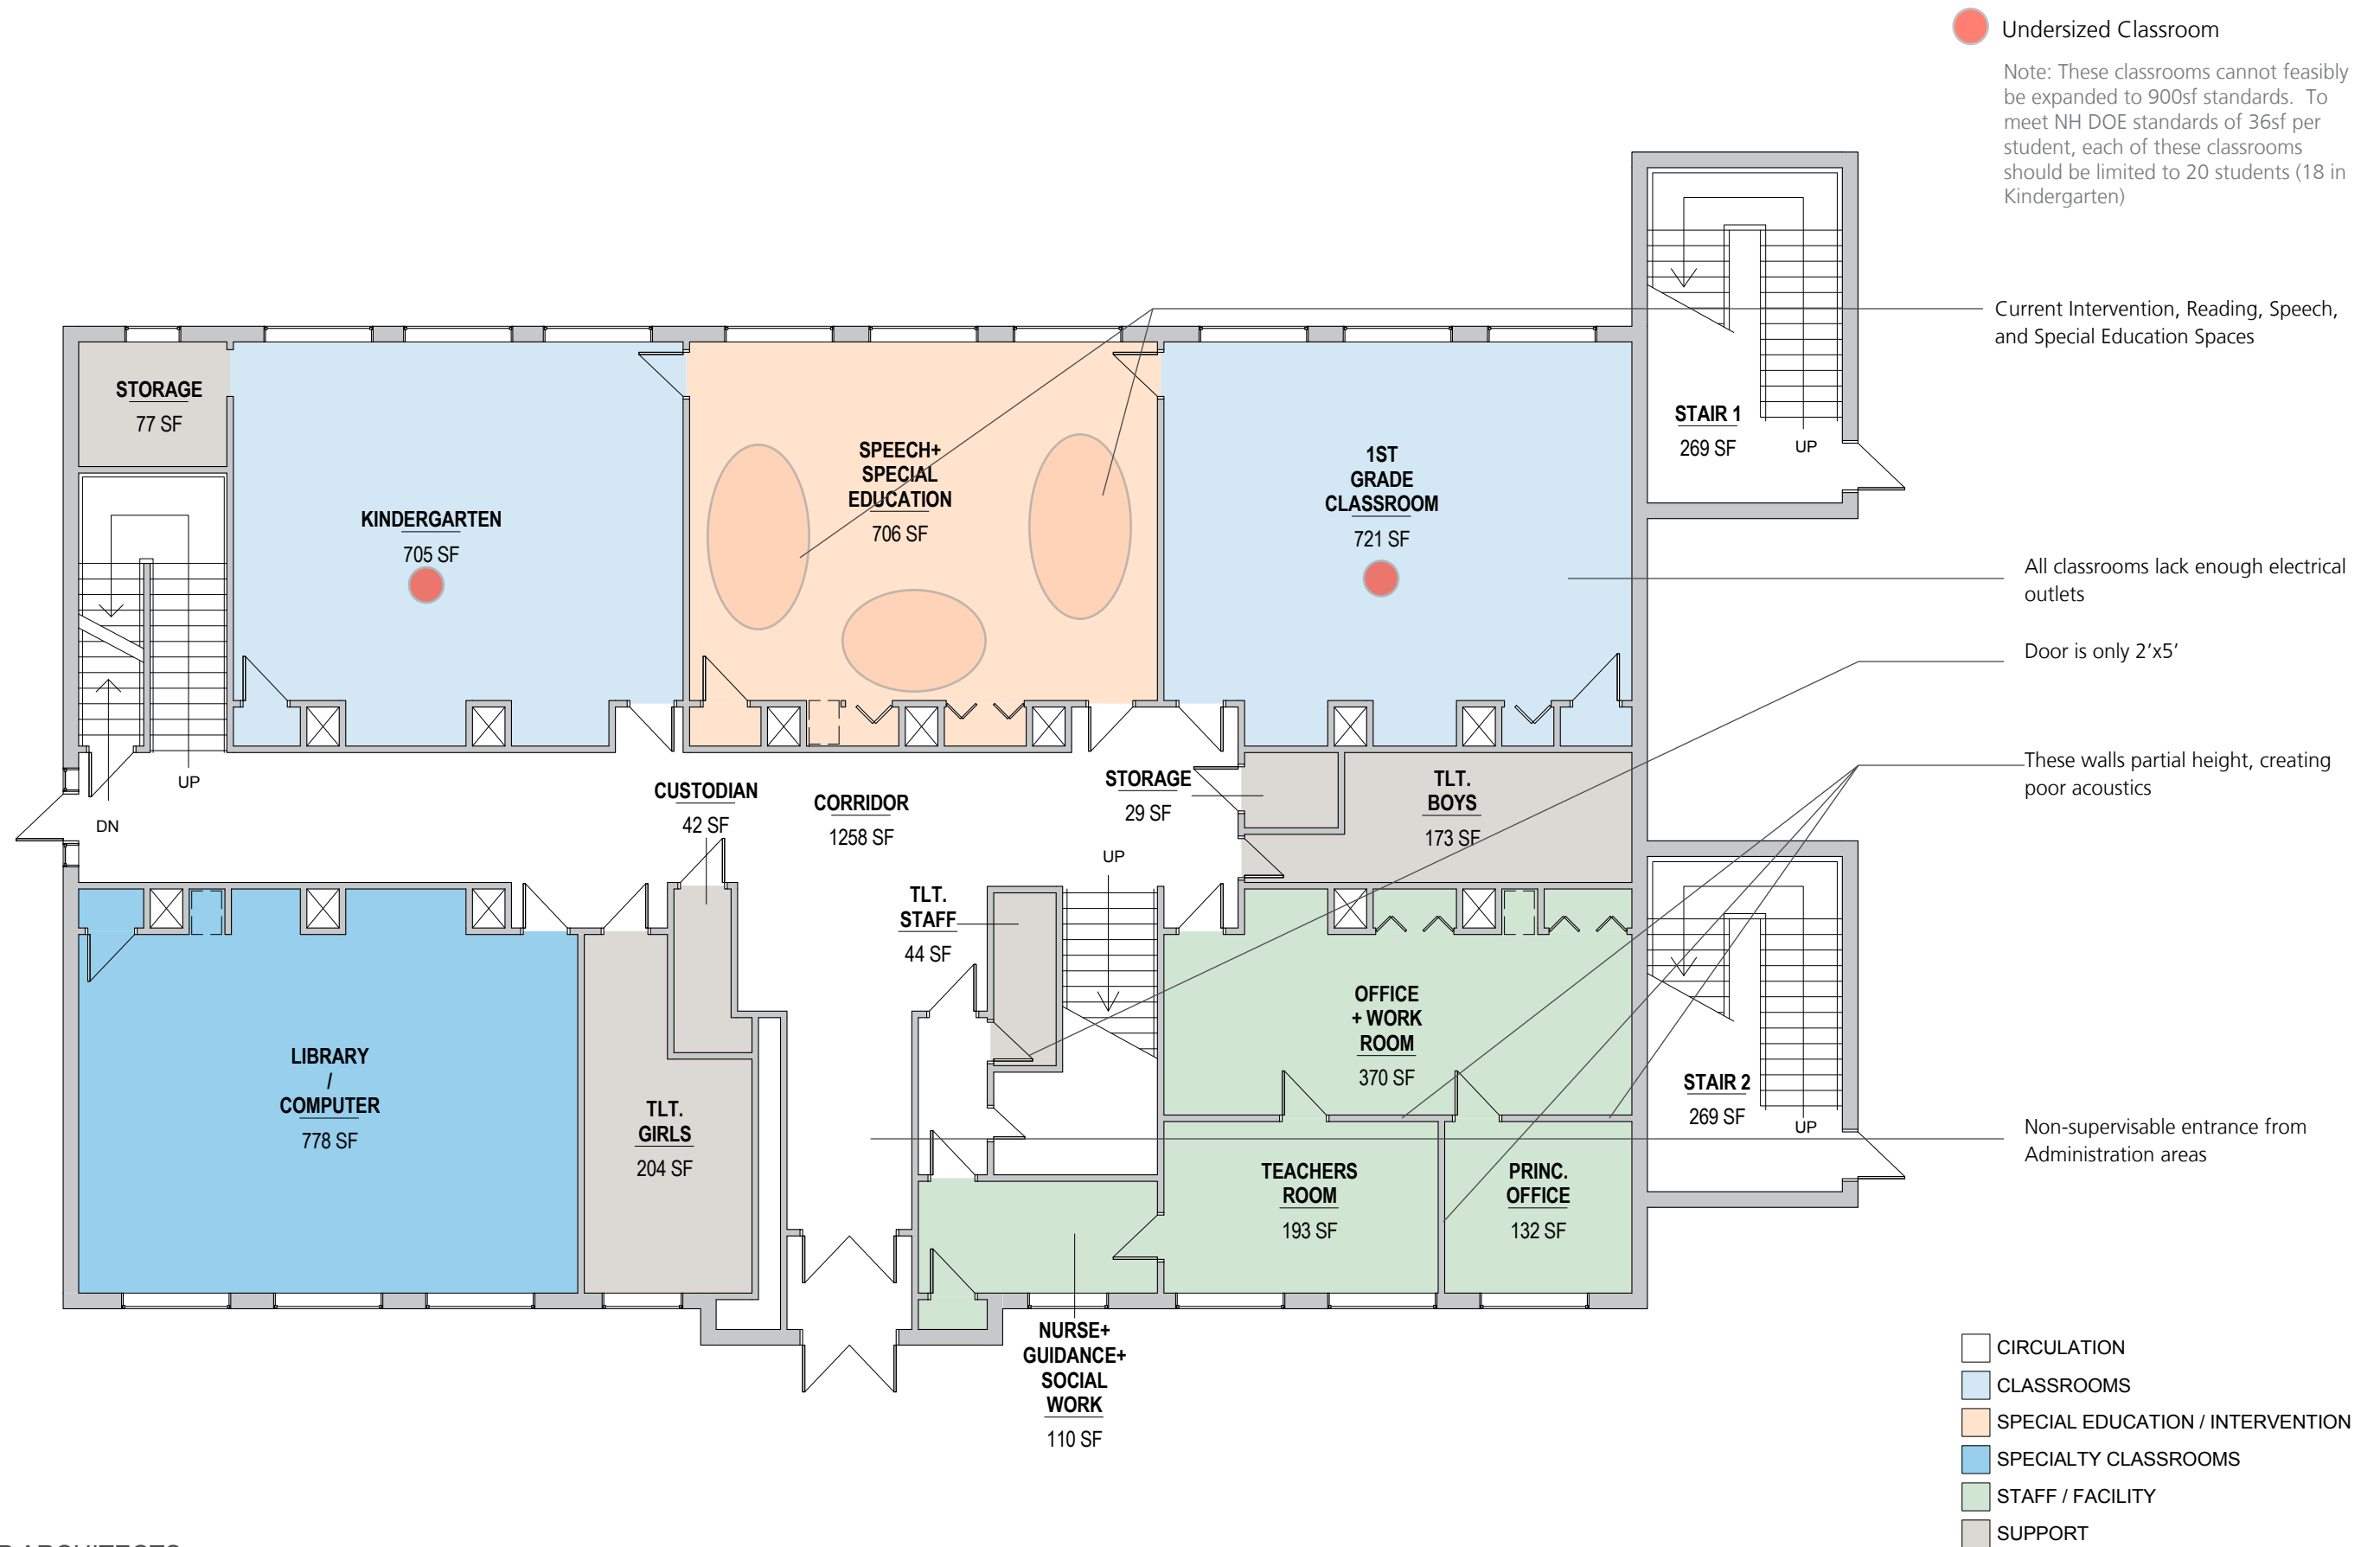
Undersized Classroom

Note: These classrooms cannot feasibly be expanded to 900sf standards. To meet NH DOE standards of 36sf per student, each of these classrooms should be limited to 19-20 students

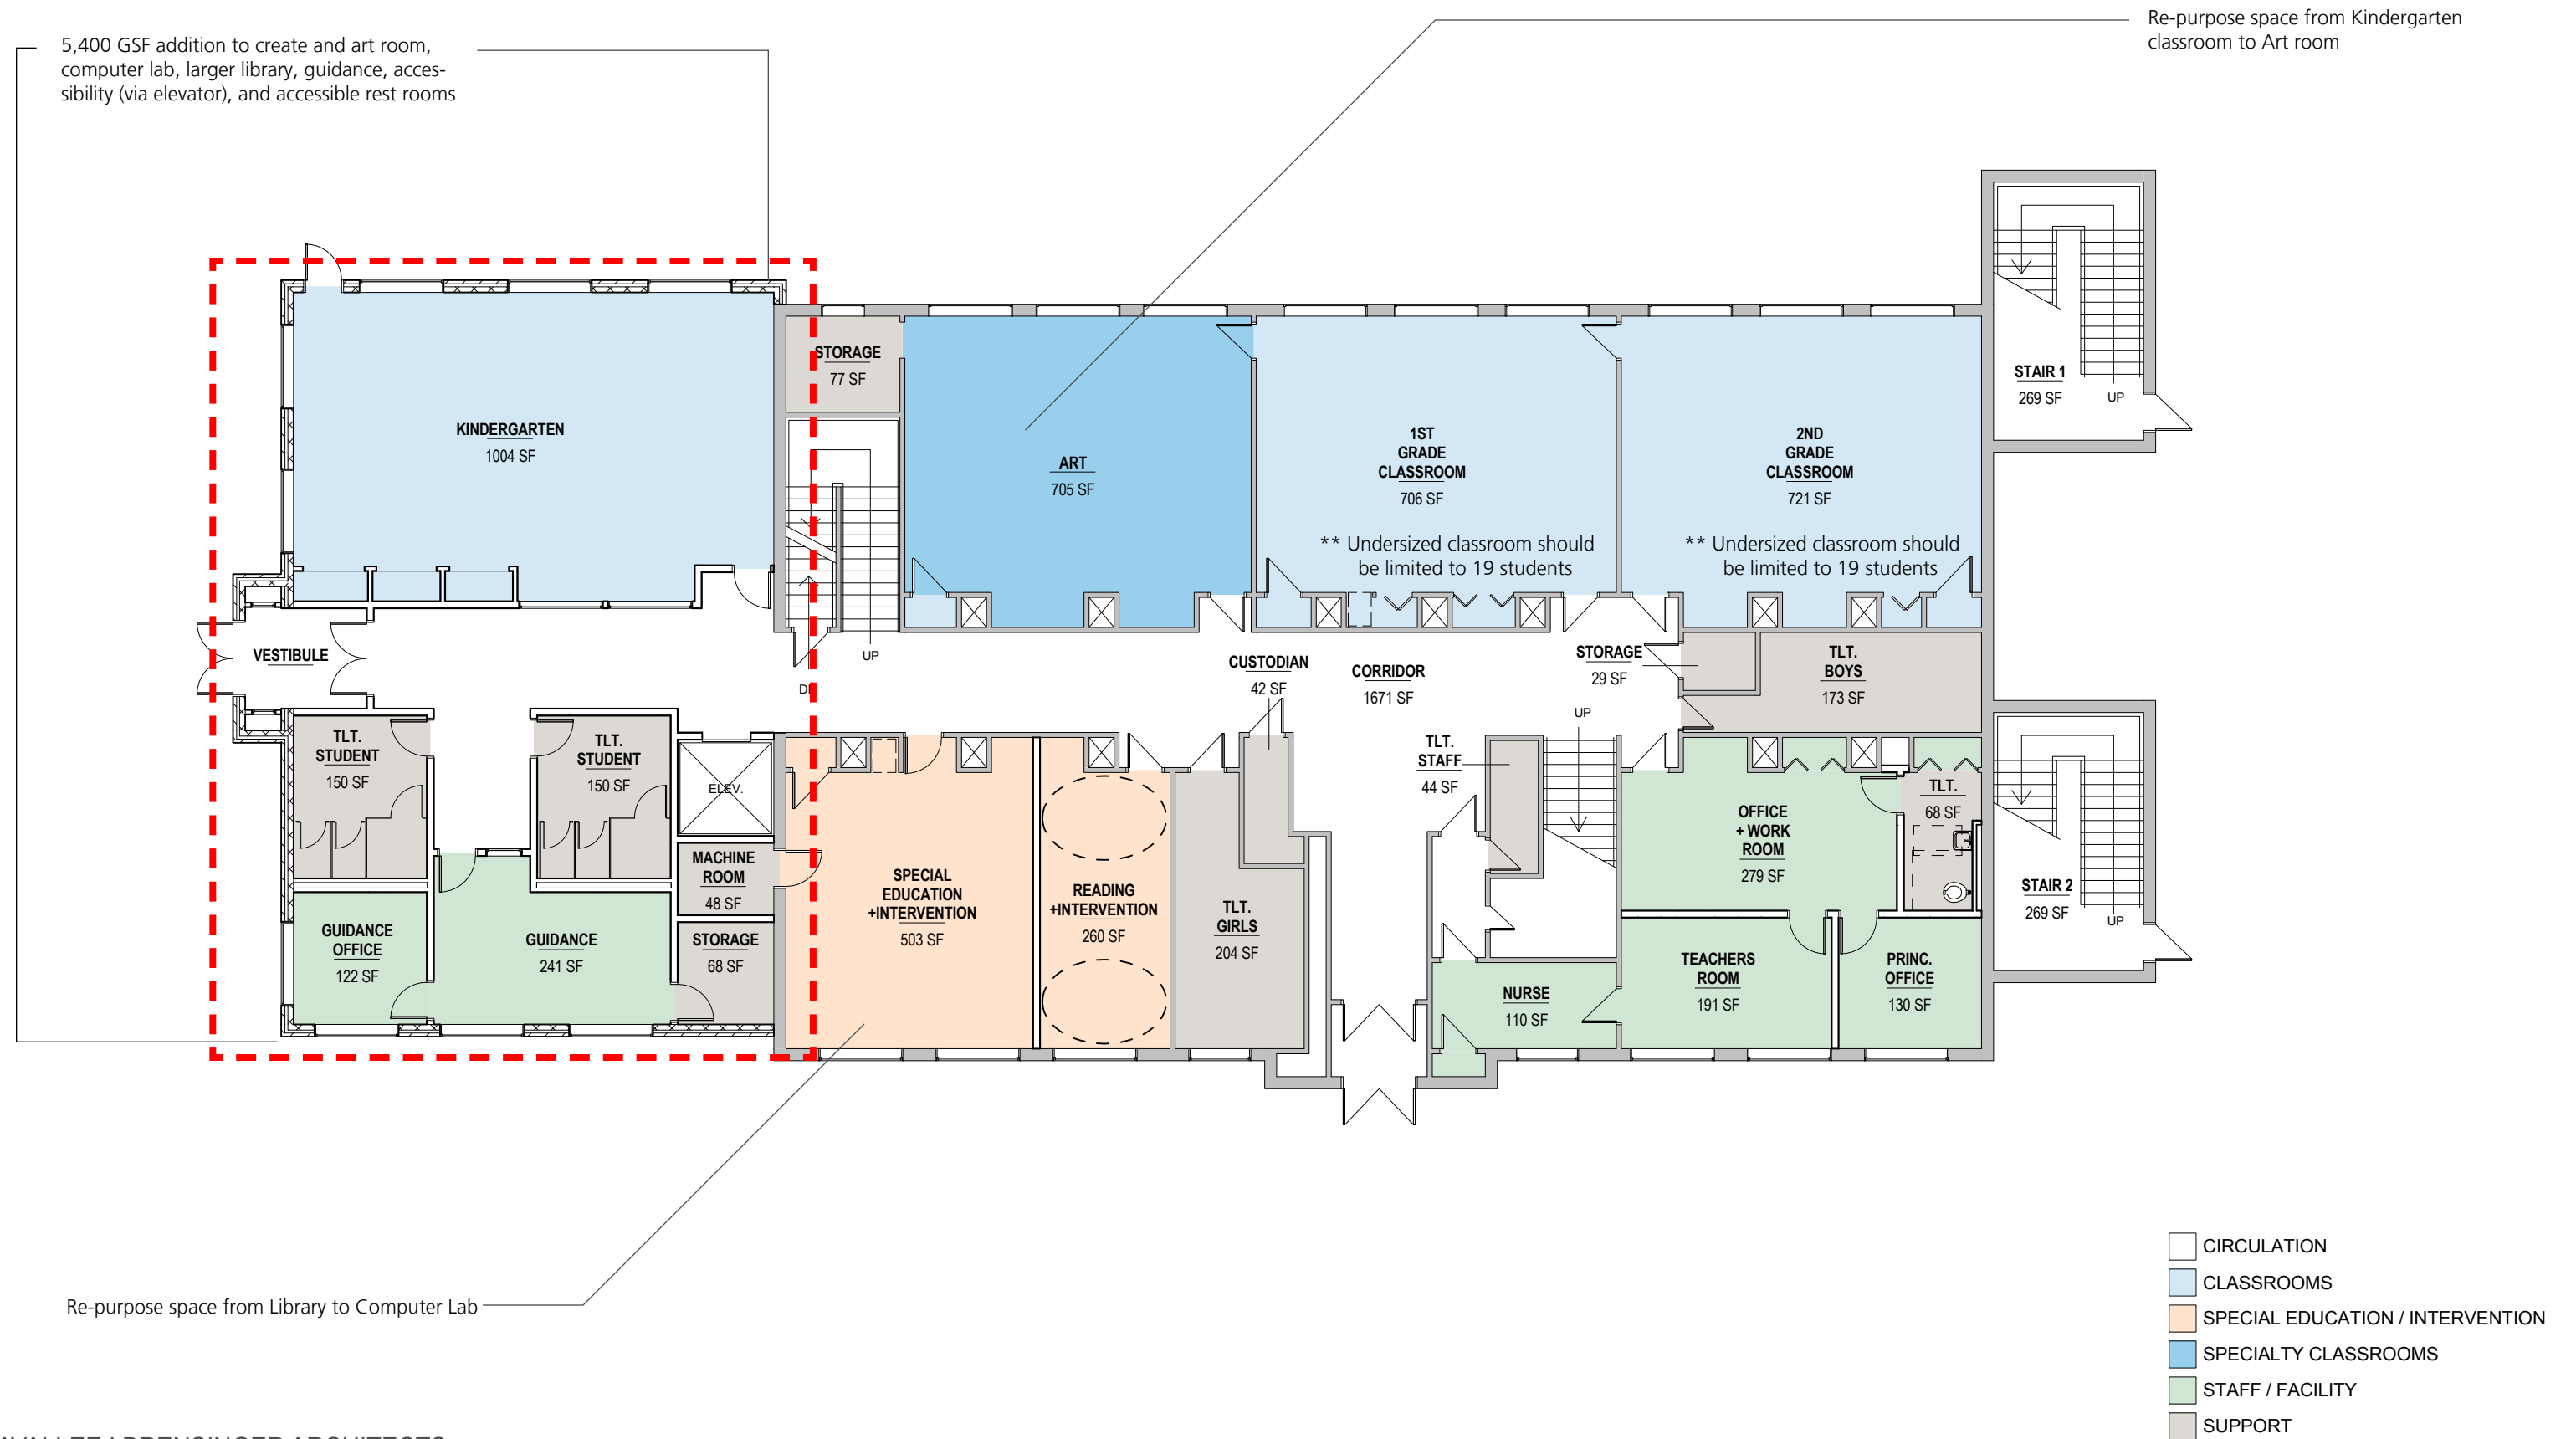
Proposed Plan - Main Level - PHASE 2

5,400 GSF addition to create and art room, computer lab, larger library, guidance, accessibility (via elevator), and accessible rest rooms

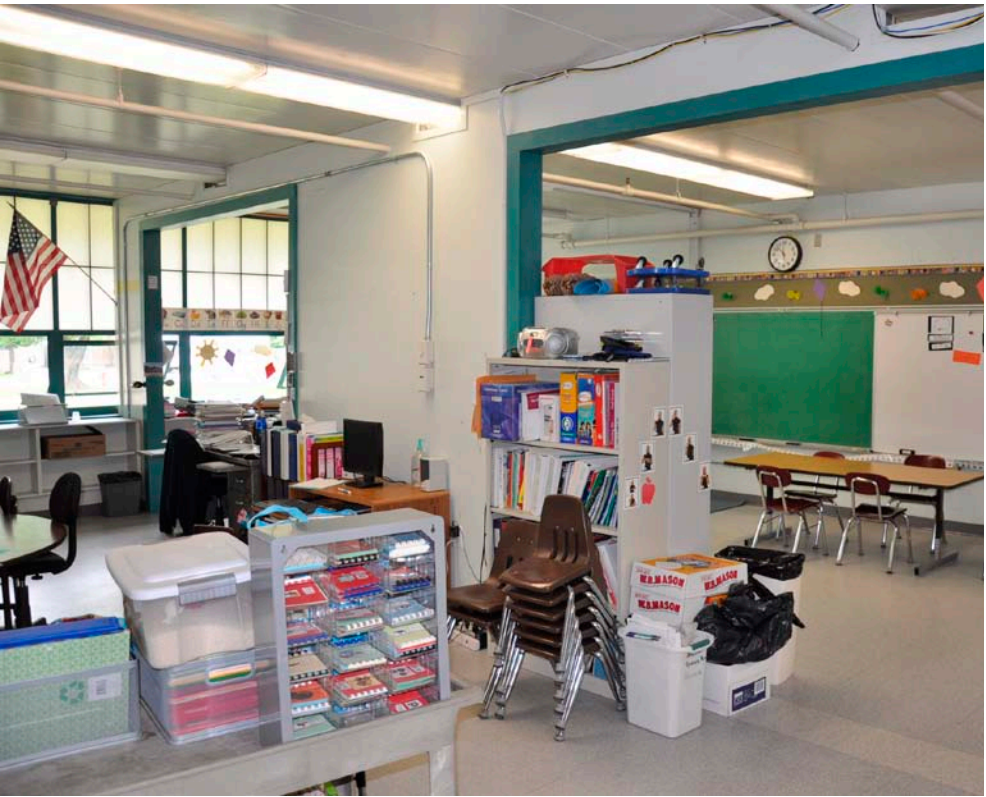
Classrooms would benefit from acoustic ceiling tile and updated technology (white boards or interactive white boards).

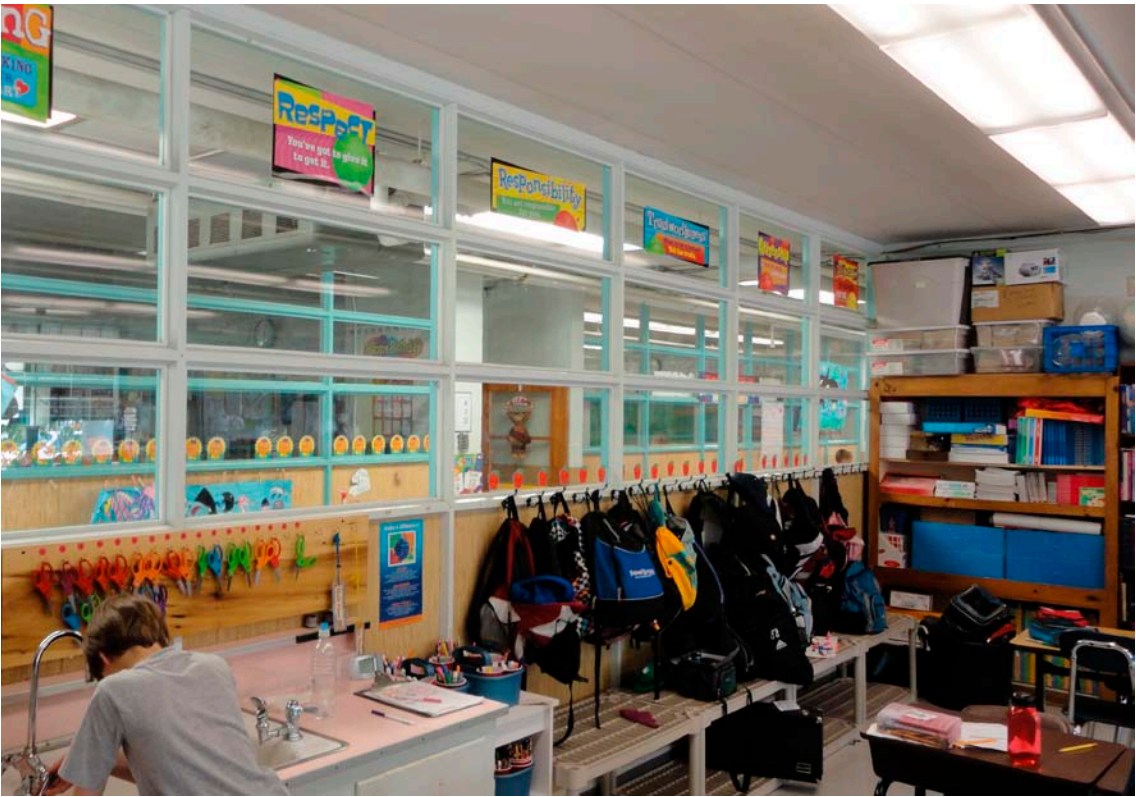
Lack of storage is apparent in classrooms but could be remedied with some added wardrobe cabinets or similar casework and some purging.

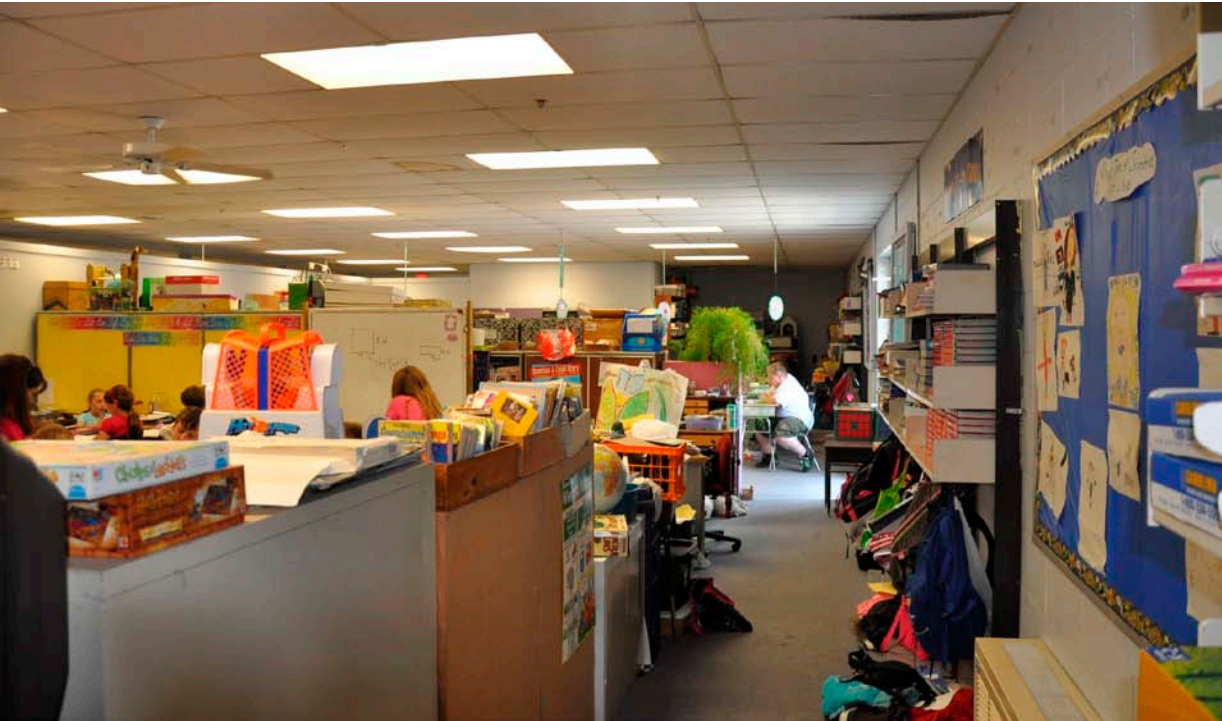
Classrooms are essentially open to one-another, separated by only partial height partitions or storage units as shown here. No acoustic separation and little natural light make for poor interior learning environments.

Demolish and renovate 16,800 GSF in order to remove all partial height partitions and replace with full height partitions to provide better acoustic quality and fire and smoke protection in egress corridors. Renovation will also provide appropriately sized Library, Computer Lab, Music + Art room, and accessible restrooms.

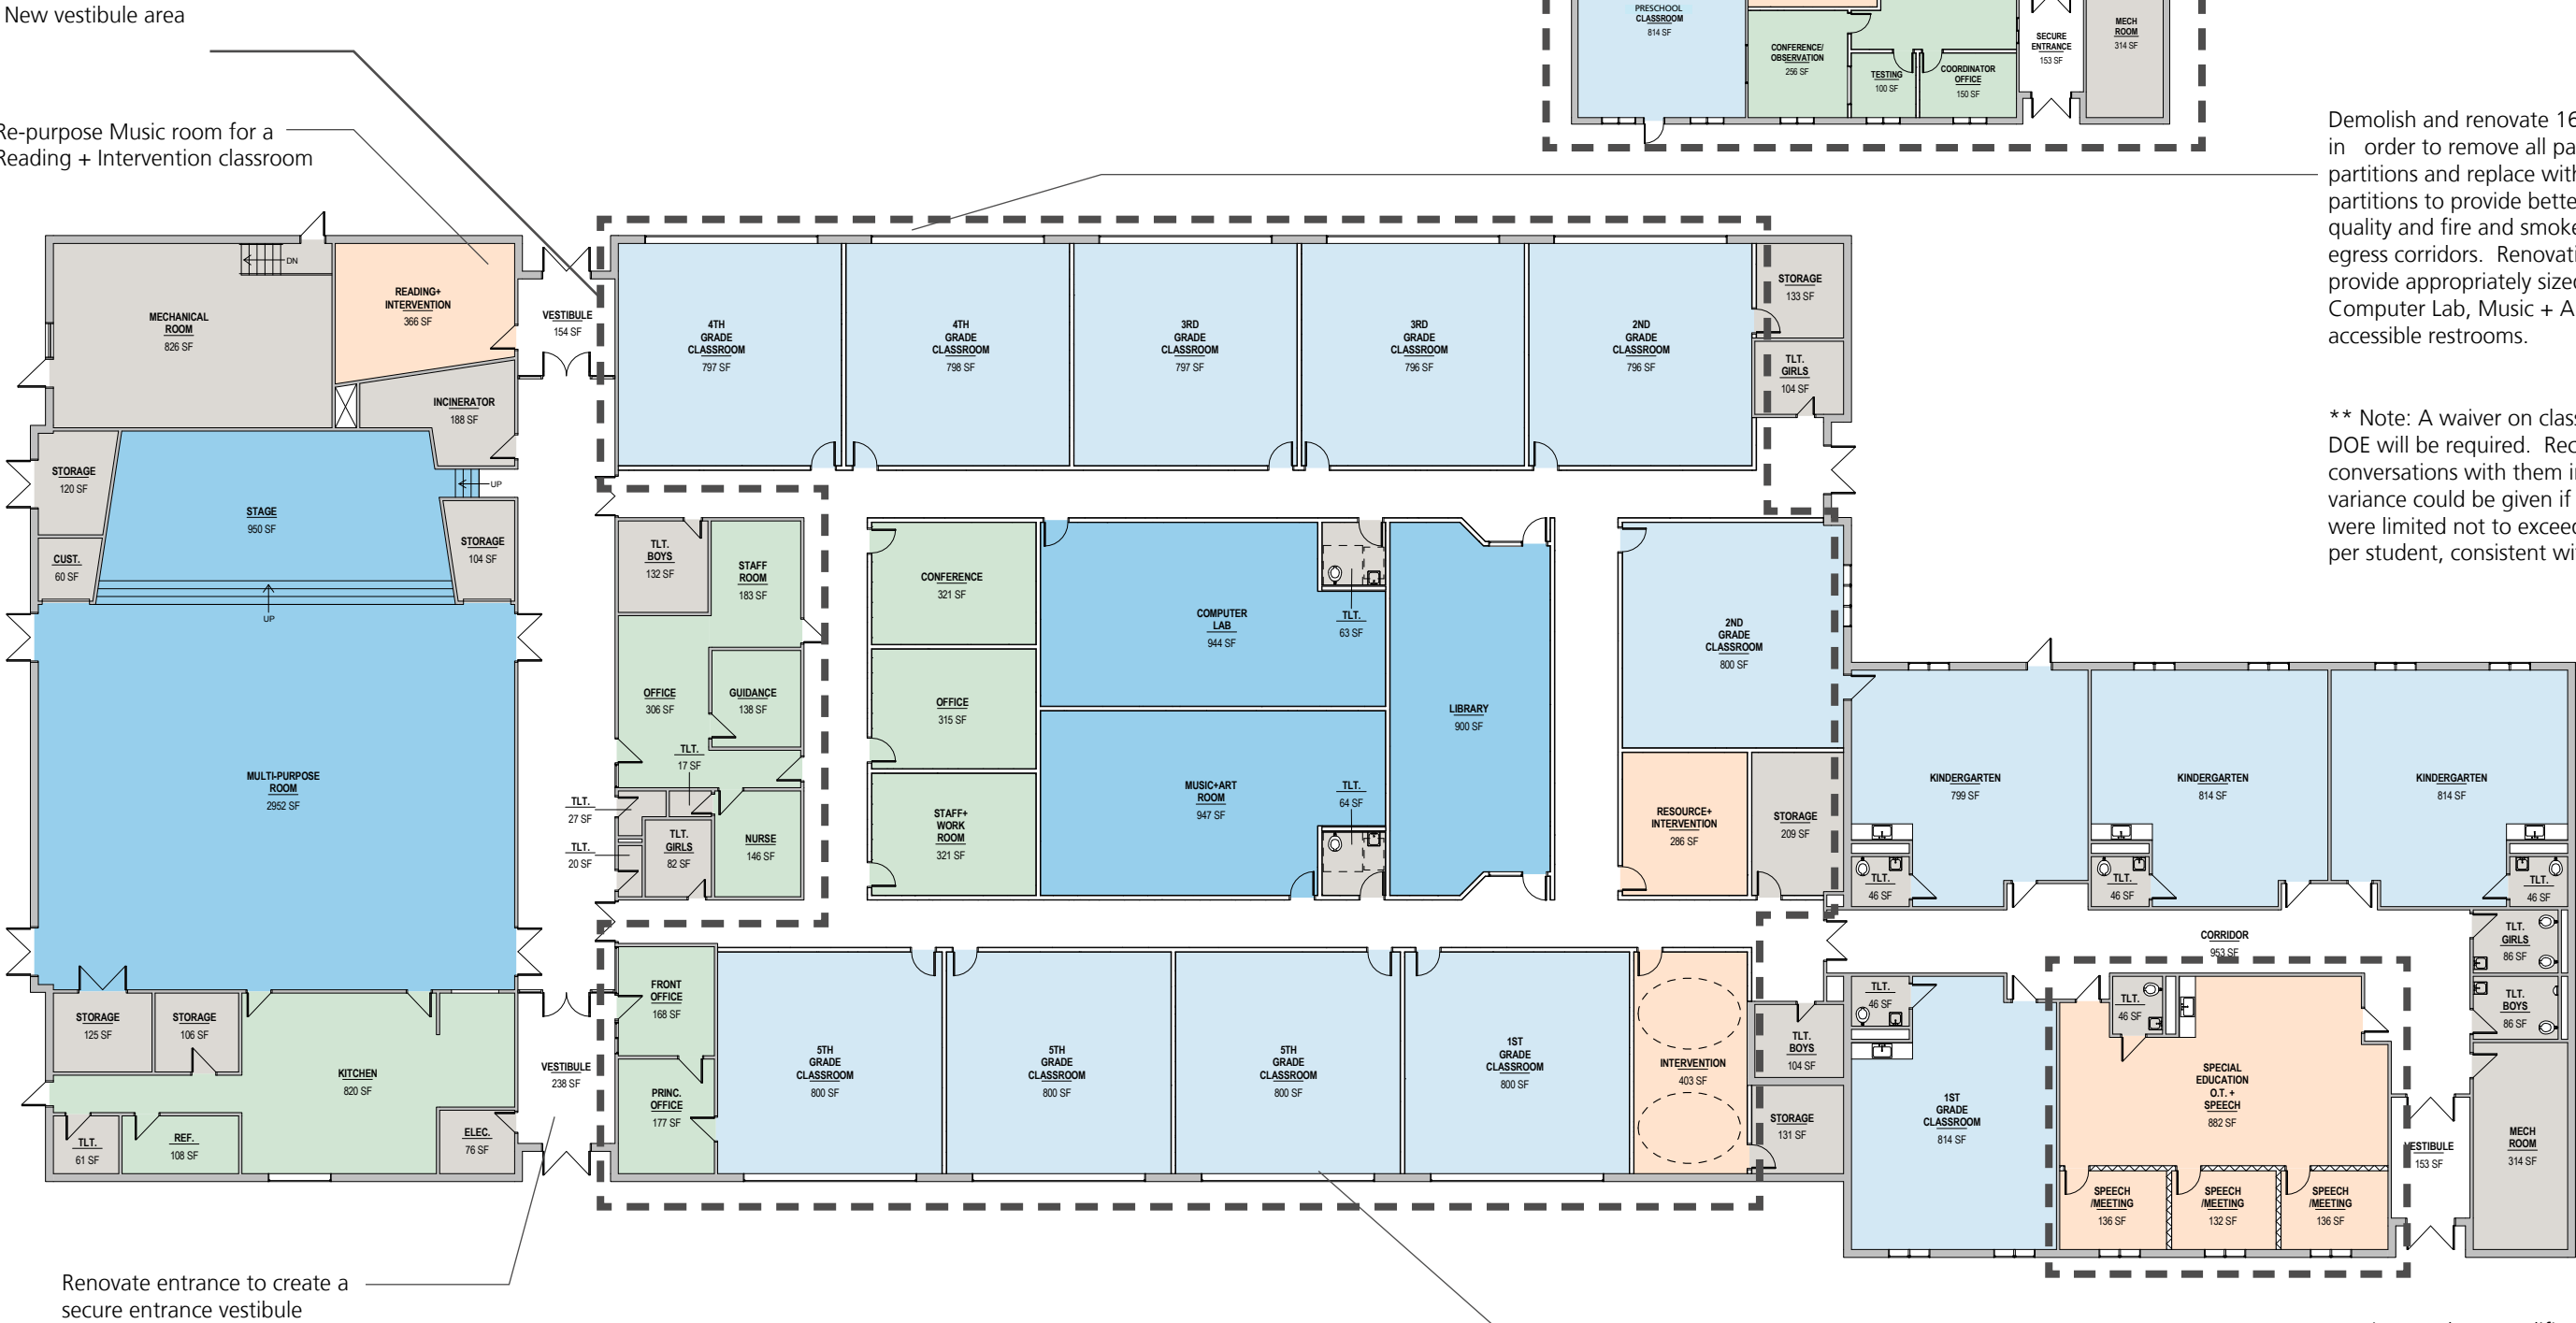
** Note: A waiver on class sizes from the DOE will be required. Recent conversations with them indicate that variance could be given if class sizes were limited not to exceed 36 square feet per student, consistent with ED321

TWO STORY ADDITION
33,400 GSF total
Level 1 = 18,000
