The following report includes the assessments and recommendations for the Rochester School District's Pre-School through 8th Grade facilities as prepared during the summer of 2012. The information included in this report was created by Lavallee Brensinger Architects in cooperation with The Rochester School District, its administrators, and the administrators at each of the Primary Schools considered. This document reflects assessments of the existing schools created through tours of each facility, interviews with school principals and assistant principals, building programming (based on current curriculum), current building codes, and NH State Education Standards.

Project Goals

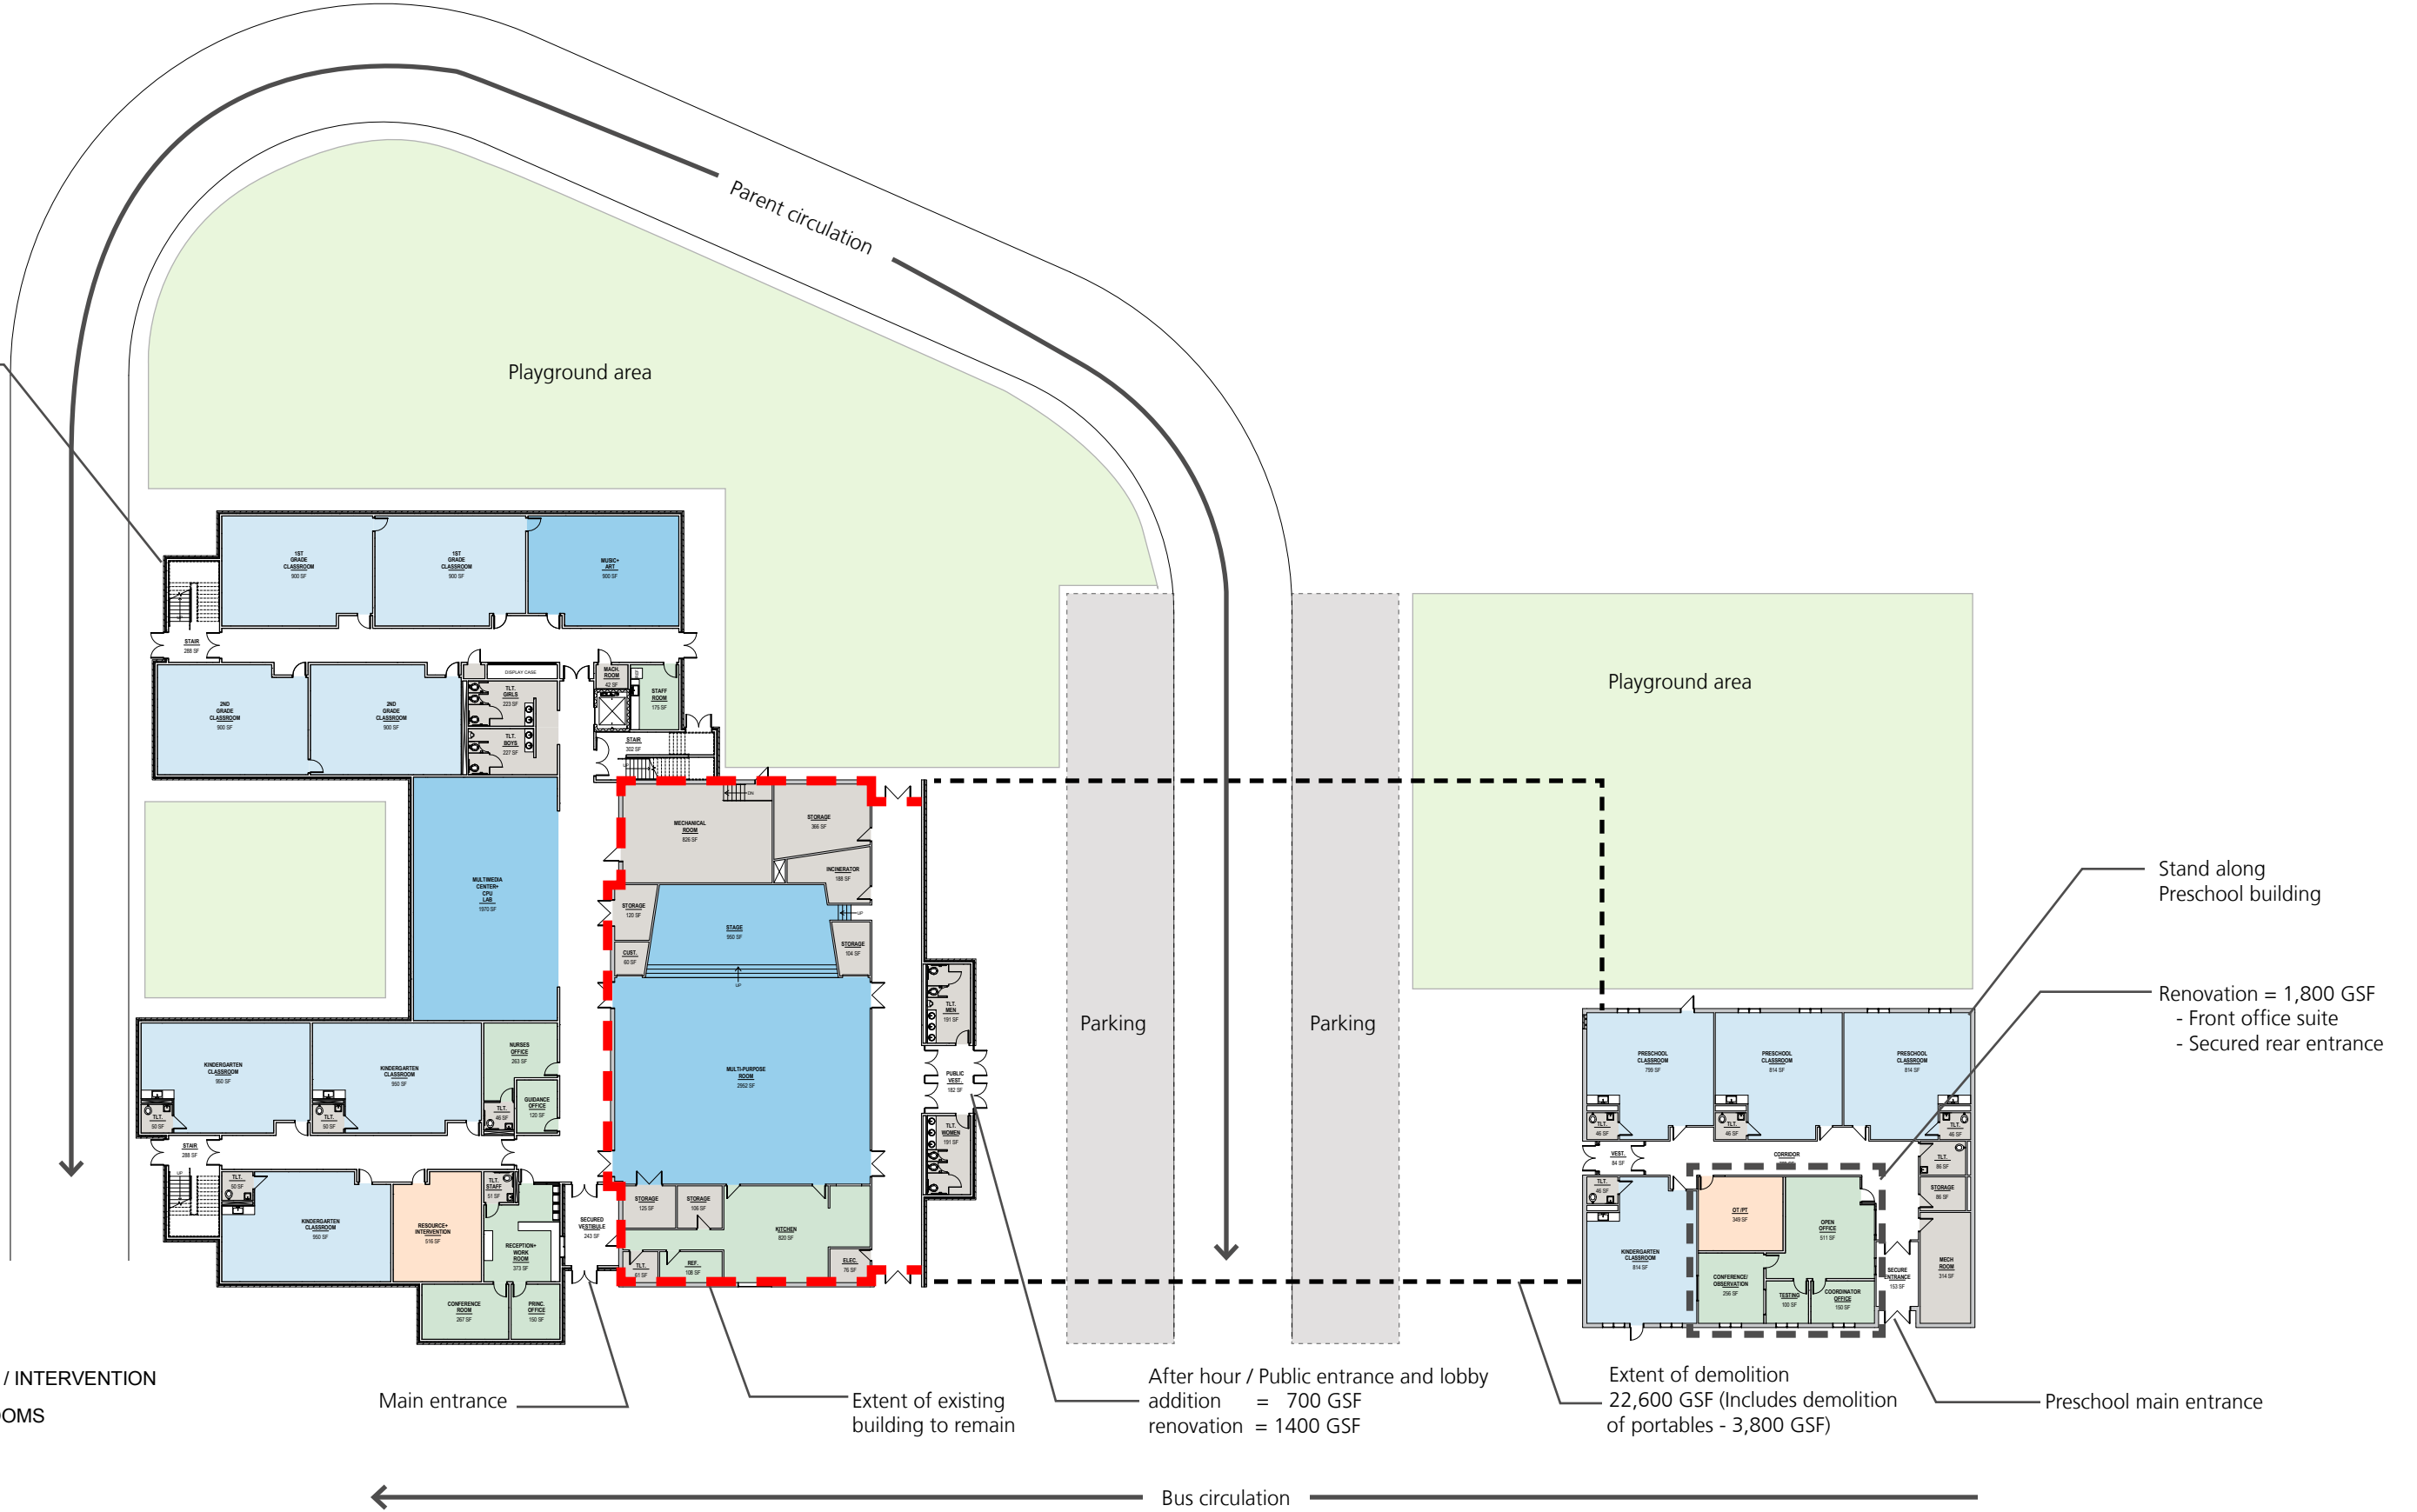
TWO STORY ADDITION
33,400 GSF total
Level 2 = 15,400

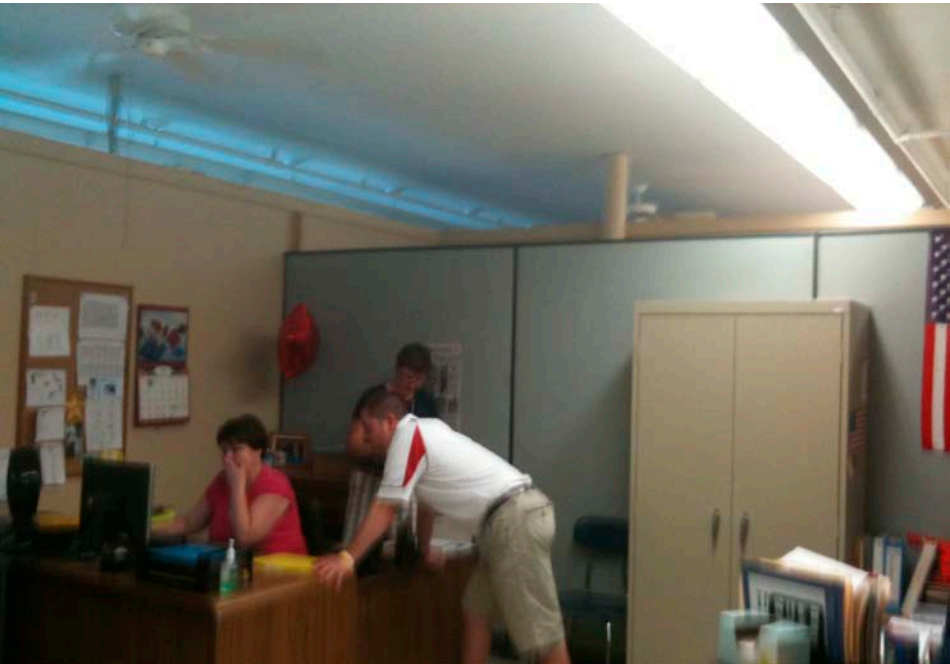
Partial height walls dividing the main office from student intervention areas provide for no acoustic separation. Similar conditions existing in many areas of the school.

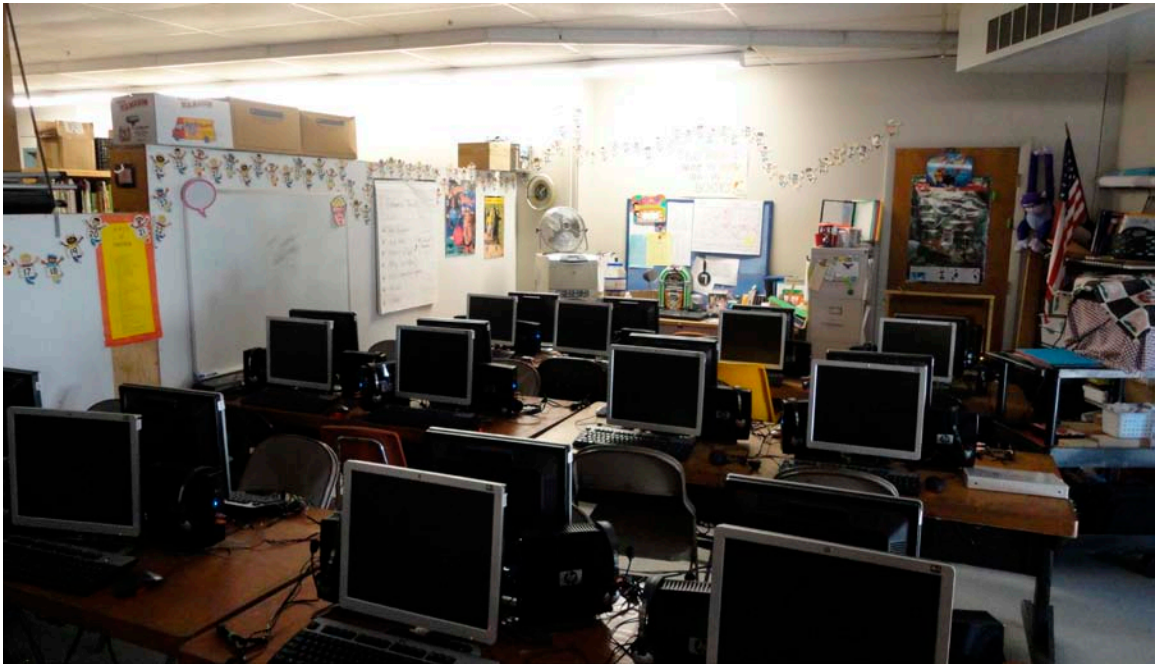
Lack of space in the Media Center and the Computer Lab is compounded by poor acoustic separation to render these areas inadequate for educational needs. Reconfiguration and renovation could remedy these issues.

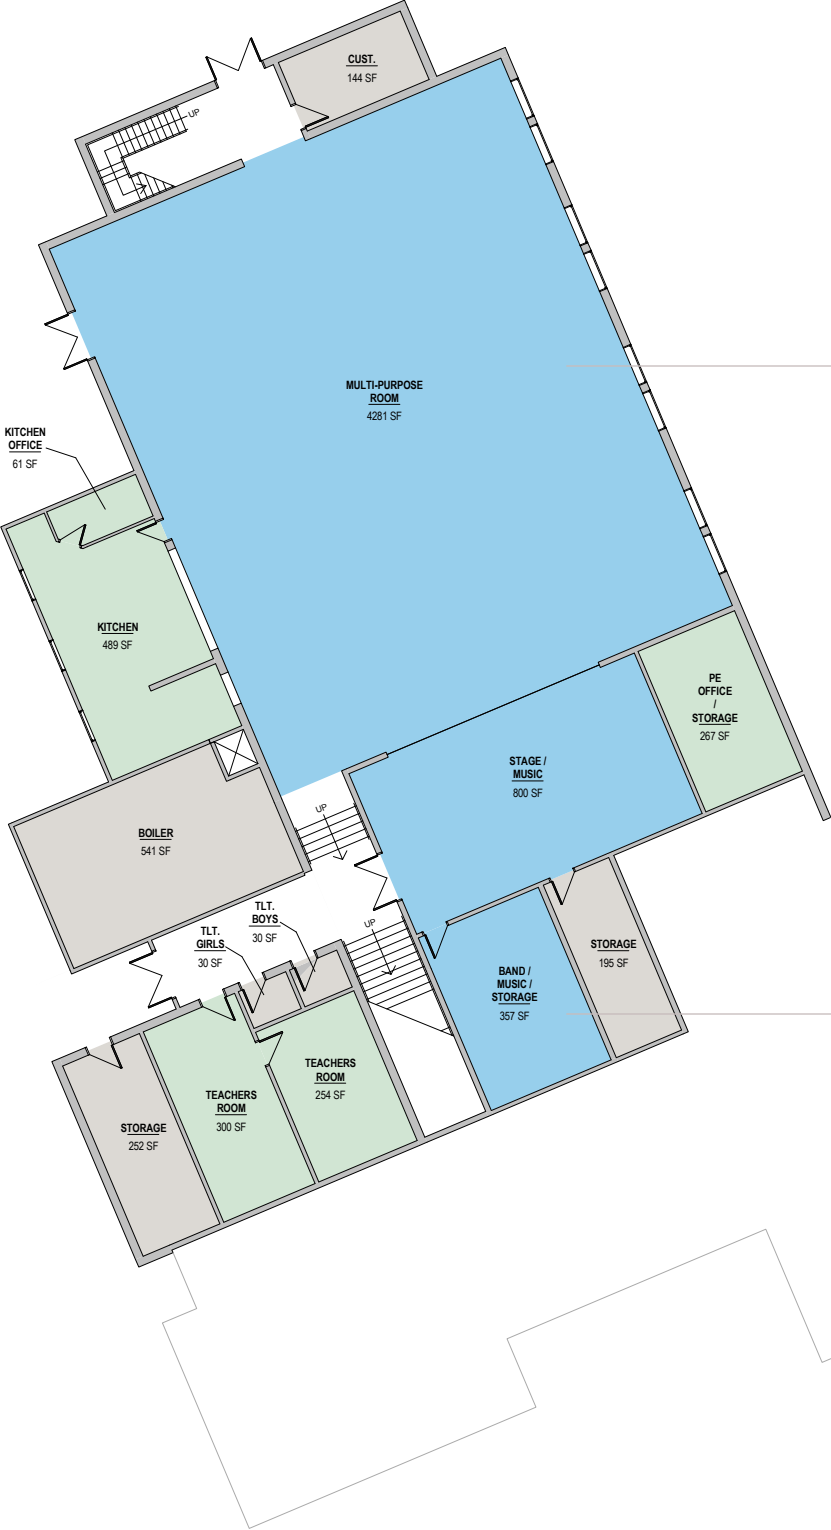
This level is non-accessible without an elevator

Band Room undersized

Current Intervention Space poorly located

No acoustic separation in these spaces

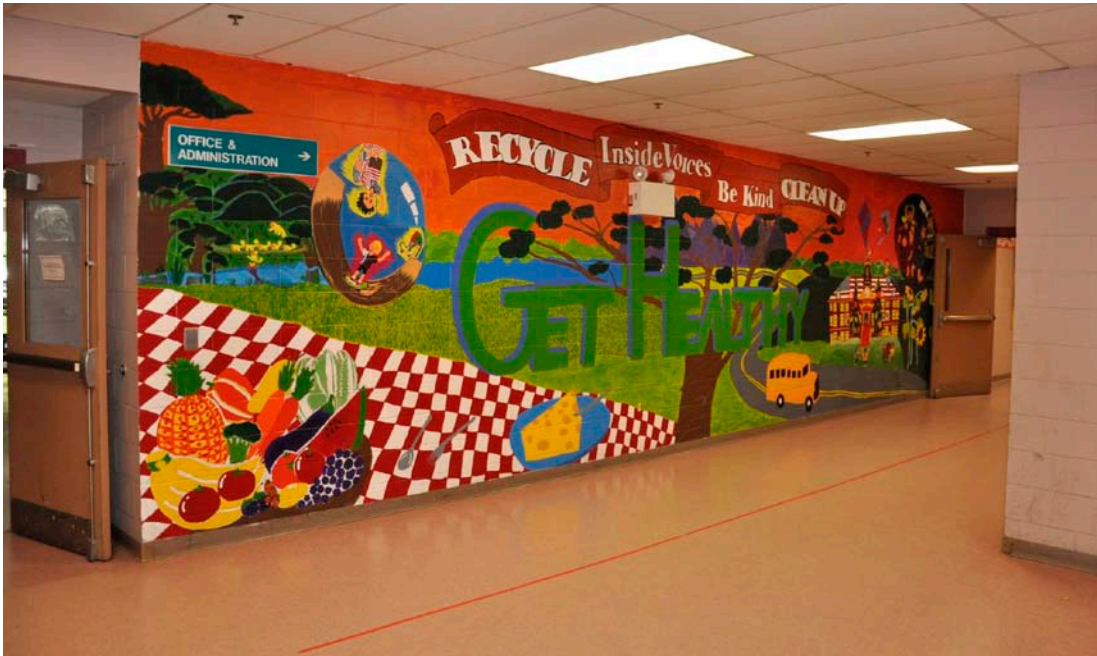
Student created wall murals give life the Rochester Middle School. This effort should be embraced.

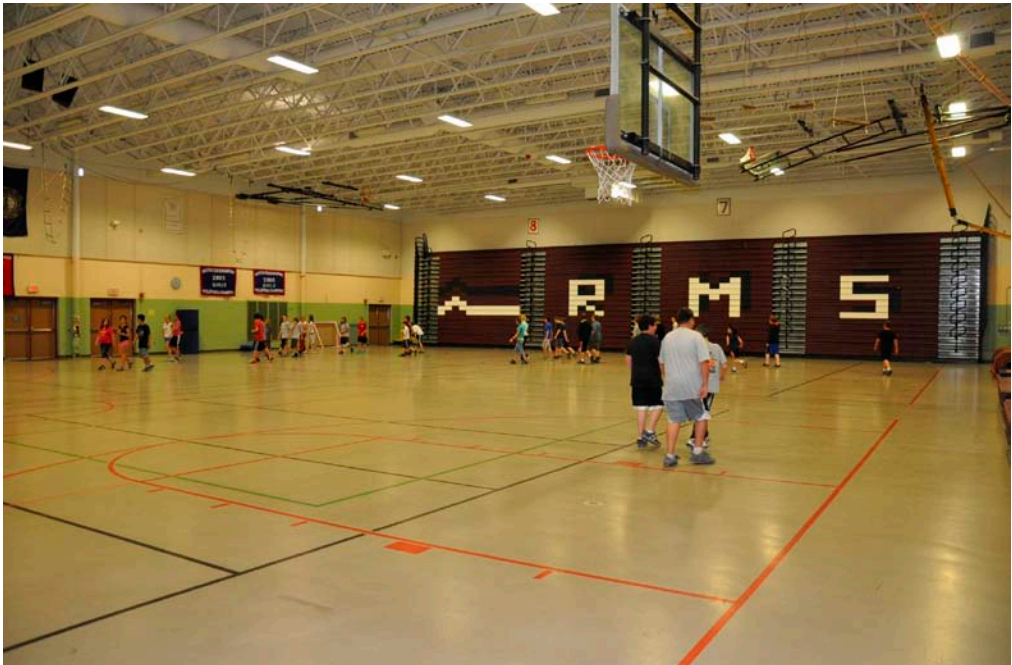
Some areas, like the gymnasium, lack natural light. To remedy this, diffuse lensed skylights could be provided, along with daylight harvesting sensors, to both improve lighting and provide energy savings. Cost effective solutions include packaged round skylight units (such as Solar-tubes), small rectangular packaged units, or pyramidal skylight units.
